Docket No. 217 – Development and Management Plan Inspection

Northeast Utilities Service Company Certificate of Environmental Compatibility and Public Need for the construction of a 345-kV electric transmission line and reconstruction of an existing 115-kV electric transmission line between Connecticut Light and Power Company's Plumtree Substation in Bethel, through the towns of Redding, Weston, and Wilton, and to the Norwalk Substation in Norwalk, Connecticut.

Date: July 28, 2005

Location: 115 kV Underground Route

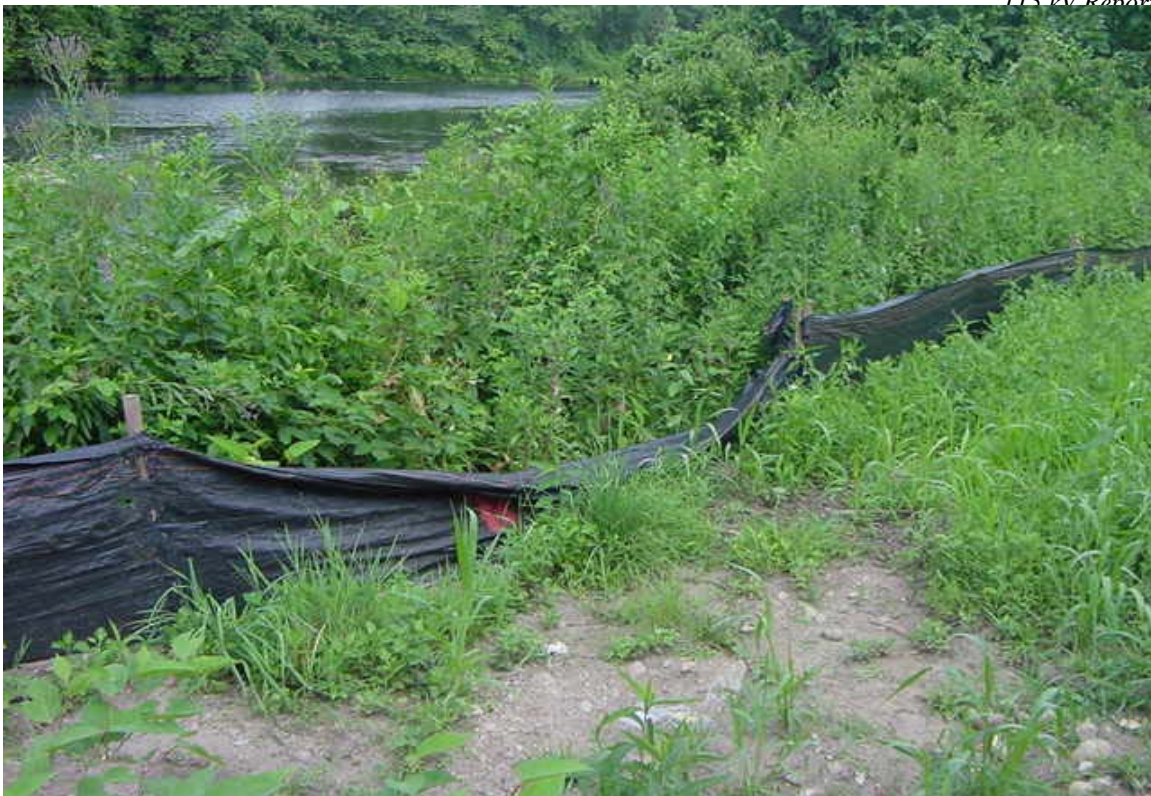
115 kV (Broad Street): Some areas along the silt fence at the edge of the ROW could use repair until the vegetation has fully reestablished. 7/28/05

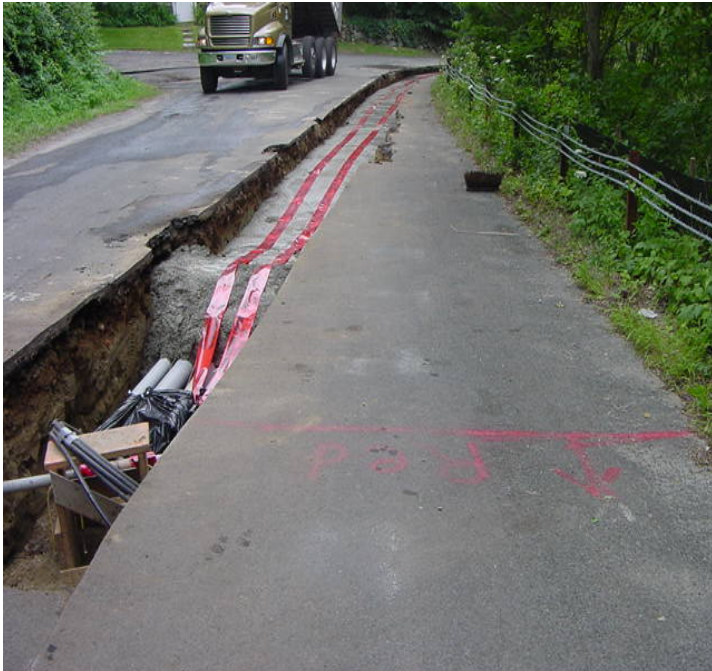
115 kV (Gallows Hill Road, Redding): The trenching and conduit installation has reached the intersection of Gallows Hill

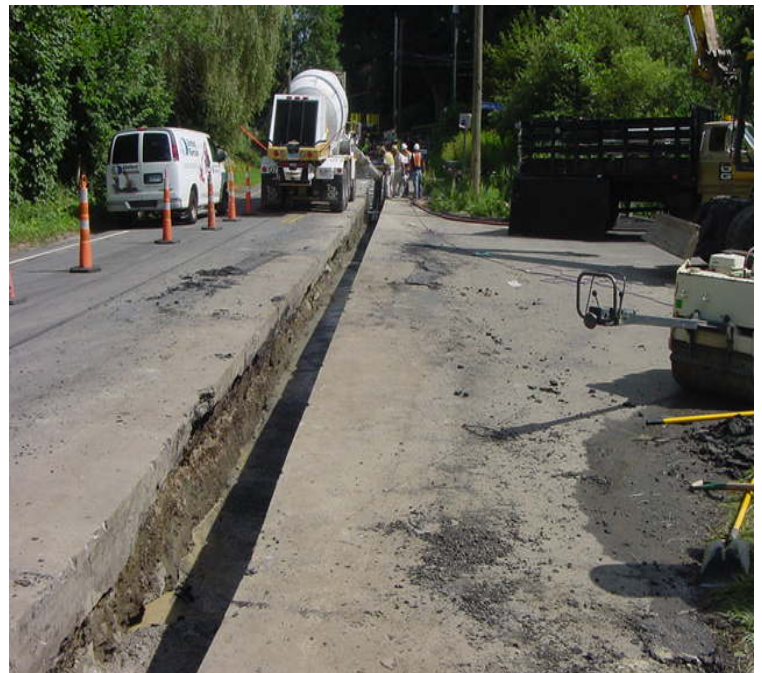
115 kV (Rt. 58, Bethel): View of the trench being flow filled and concrete being poured near reached the and Rt. 107. 7/28/05

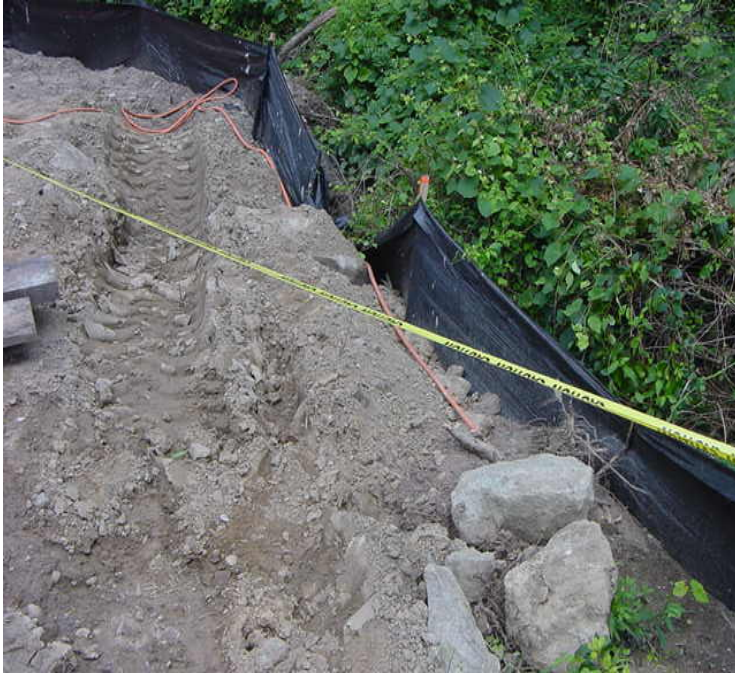
115 kV (Route 58, near Hoyts Hill- Transition Pole): Soil is still overtopping the silt fence near the caisson drilling (photo on left). Repairs are still needed to the silt fence along the access road. (photo on right)
7/28/05

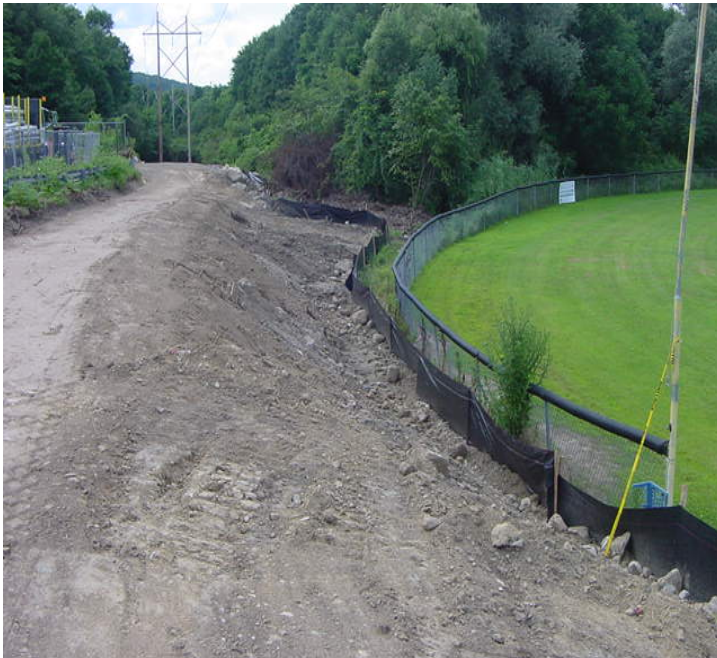
Soil has been pulled back from the silt fence and the trench has been backfilled in the ROW near the RT Johnson school (photo on left). View of the ROW past the Bethel Middle School (photo on right). 7/28/05

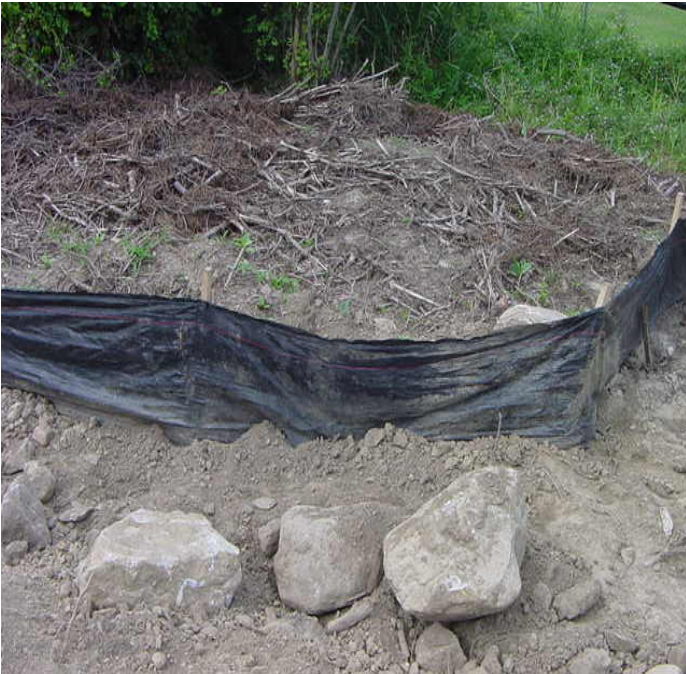
115kV (Bethel Education Park) Brush was piled beyond the limits of the silt fence. Make sure brush and mulch/wood chips are not placed in any wetland areas (photo on left). View of the caisson in place at the southern end of the ROW (photo on right). 7/28/05

Areas of Inspection	Observation	Recommended Action
	Hill transition structure location and in several other locations. 7/28/05	protect wetlands beyond. Brush should also not be piled here in accordance with the D&M plan. 7/28/05
Staging, Storage, and Parking Areas	<p>- The original pull-off on the side of Gallows Hill Rd still has silt fence is well in place but sediment has washed to the shoulder of the roadway where the fence does not cover. 7/6-7/28/05</p> <p>- In Redding Town Yard, soil excavate is only temporarily stored here until it can be trucked for disposal in the O&G facility in Bridgeport or the Redding landfill. 7/28/05</p> <p>- Concrete washouts are also taking place within the Redding yard in a specified location and the area was under control at the time of inspection. New signage was placed to limit excessive water use but it was not confirmed if a check dam was placed at the discharge pipe from the catch basin. 7/28/05</p> <p>- A storage area for materials, conduit and equipment is in use at the Bethel Educational Park near the RTJ School. 7/6-7/21/05</p>	<p>- A check dam of fence or haybales should be placed or the silt fence line extended to the roadway here. 7/6-7/28/05</p> <p>- There are no current issues but if the piles progress beyond the bins, haybales should be placed down-gradient of the pile unless this is in the way of active equipment movement. 7/28/05</p> <p>- The bin should continue to be emptied regularly to prevent escape of the wash water and an emergency overflow check dam in place. 7/28/05</p> <p>- None at this time- well contained. 7/21/05</p>

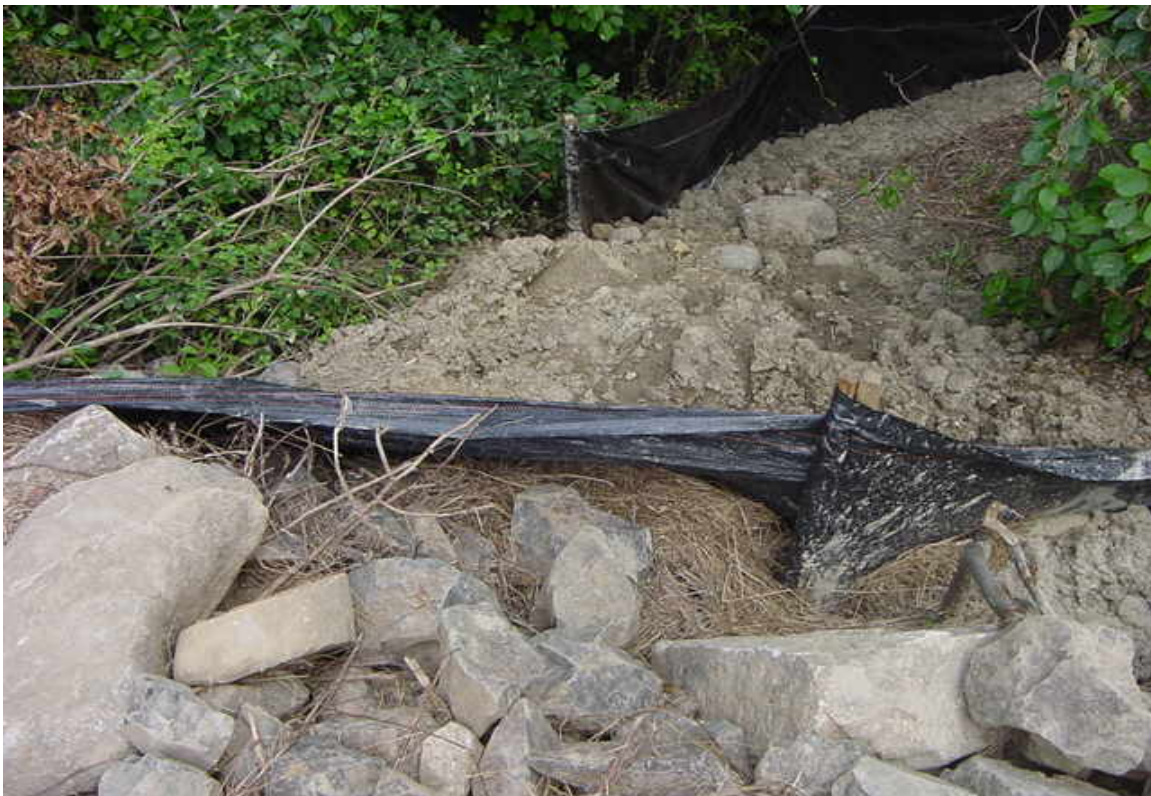
A second row of silt fence was installed to encompass disturbed soil but it must be extended to meet the first row of fence. 7/28/05

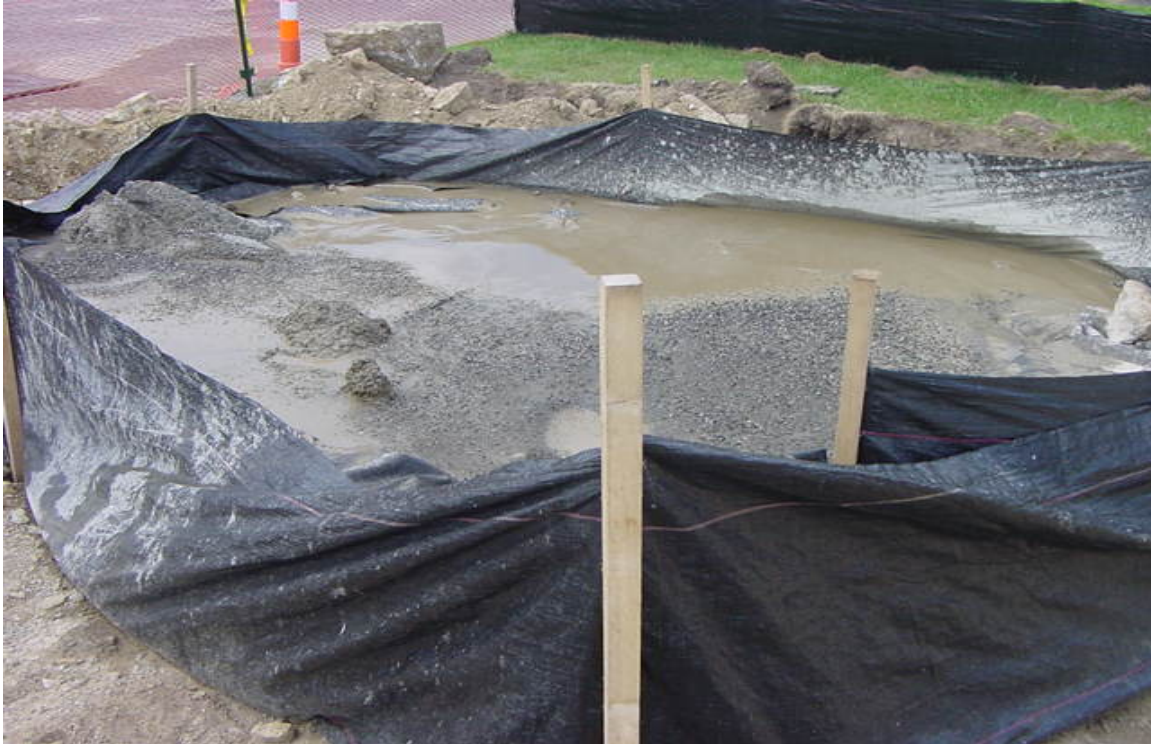
A concrete washout corral was built in the Education Park to handle this area's washouts. Continue to maintain when necessary. 7/28/05

Spills and Material Storage	- A new designated concrete washout corral was constructed at Bethel Ed. Park. 7/28/05 -Leaks were not noted from the machinery during this inspection. A report of any leaks or spills that reach the ground and occur during the week will be provided to BSC from internal project inspectors 6/15-7/28/05 - Catch basins, inlets and swales should be protected especially in any area with sawcutting activities. Slurry muds are highly mobile and can reach inlets hundreds of feet away when conditions are right. 7/21-7/28/05	-Continue to make sure concrete washouts are restricted to designated areas. This should be sure to continue. 7/28/05 - Equipment and materials should not be stored in wooded areas unless it is designated for storage. 7/28/05 - The contractors should remain vigilant about securing and handling fuel containers. Continue to keep all vehicles maintained well (i.e. no apparent fluid leaks) if they will be used or stored on site. Check equipment status on a regular basis and keep spill kits on hand. Report spills immediately, even if they are being controlled.

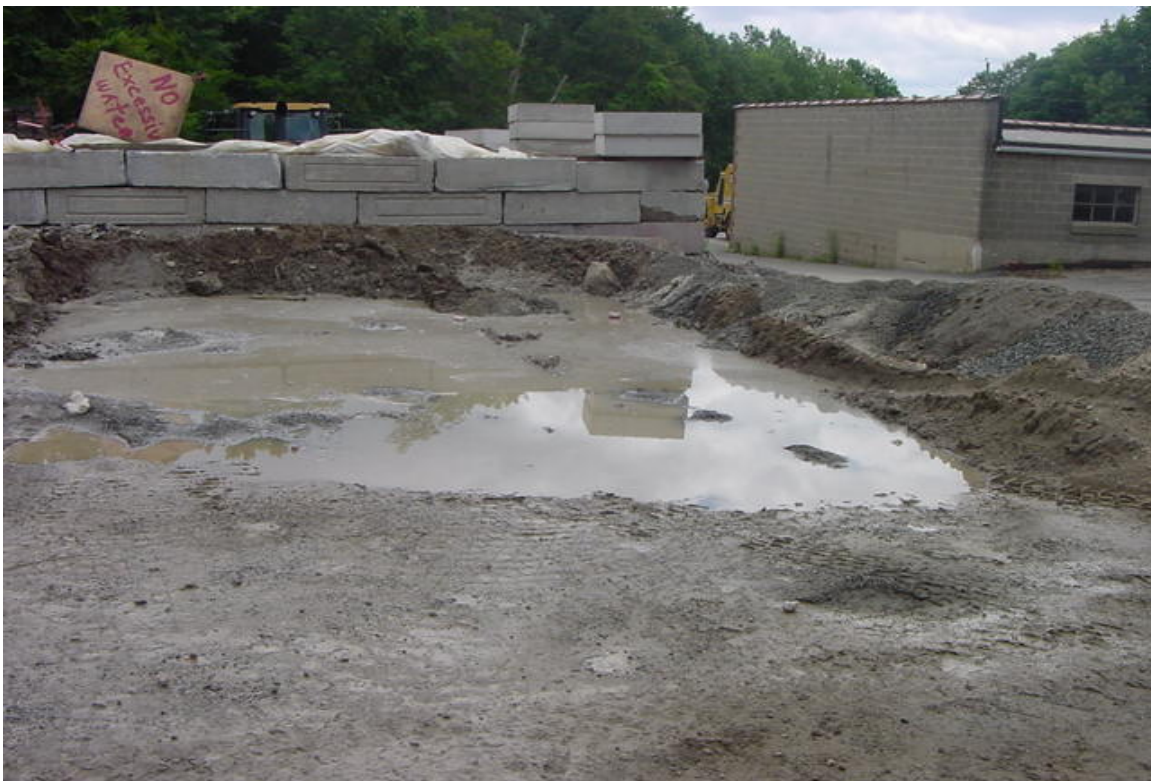
115kV (Redding Town Yard): The concrete washout area here has been placed with signage to prevent excess water that would quickly fill up the station. 7/28/05
